INDEPENDENT ENVIRONMENTAL COMPLIANCE AUDIT

INTERMODAL LOGISTICS CENTRE – ENFIELD, NSW

DECEMBER 2016

Document Information	
Document Reference:	Independent Annual Environmental Audit no. 8
Audit Organisation:	QEM Consulting Pty Ltd
Auditor & Author	Larry Weiss
Qualifications	Exemplar EMS Auditor Certification 12355 exp. April'19
Date of Audit	13 th December 2016
Report date:	24 th January 2017

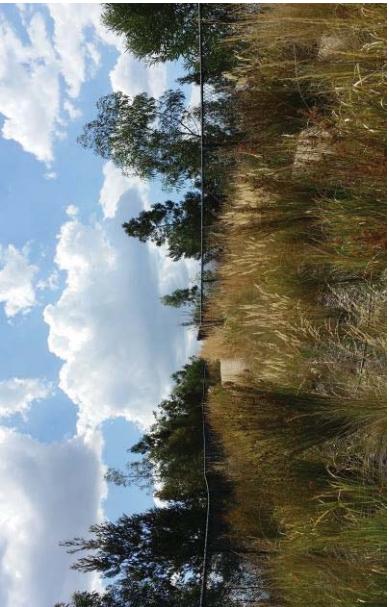
ITEM	REFERENCE	VERIFICATION / REQUIREMENT	EVIDENCE OF IMPLEMENTATION	COMPLIANCE STATUS
33.		Continued: Site operation, maintenance and management	Revegetation of Mount Enfield had progressed since the last audit e.g. the photo below shows the area alongside the public pathway to the lookout.

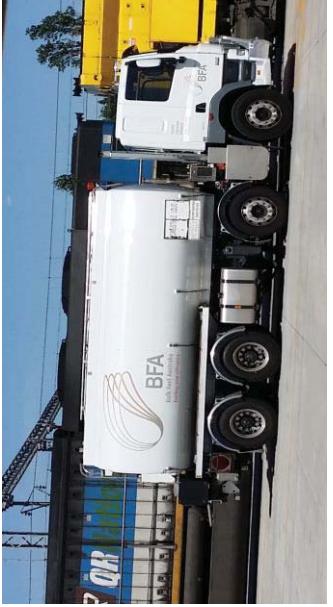
51.	OEMP 3.5 SW 2 SW 3 SW 5	Water Quality and Stormwater Management - implementation of controls including: <ul style="list-style-type: none">• Wash down and other water treatment• Fuel Storage• Spill Response• Direct Locomotive refuelling	<ul style="list-style-type: none">• Wash down of containers with taking place in designated areas leading to recycling of water used.• Refuelling observed on the day (photo below) was indicated as following procedures**

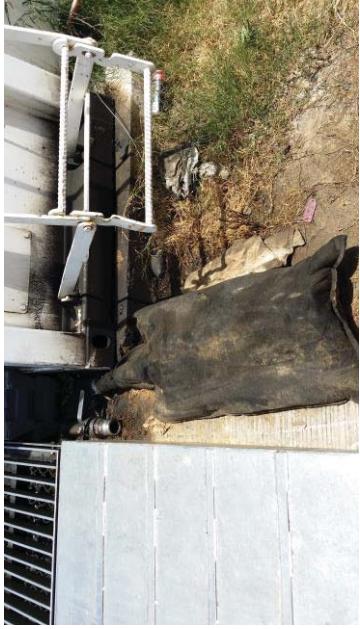
ITEM	REFERENCE	VERIFICATION / REQUIREMENT	EVIDENCE OF IMPLEMENTATION	COMPLIANCE STATUS
68.	OEMP 3.3.4 App G	Water Quality and Stormwater Management - implementation of controls including: <ul style="list-style-type: none">• Fuel Storage• Spill Response• Refuelling procedure	Refuelling Procedure SWI NAT 16 was available. A large diesel tank used to store fuel, was located on an unsealed surface with this and related issues identified by a NSW Ports audit as requiring attention.	Note
69.		Refuelling Cont'd	This audit observed some minor dripping from a broken cam lock on the filter bag on the Fuel Storage spill containment unit, shown below (see Incident Management further)

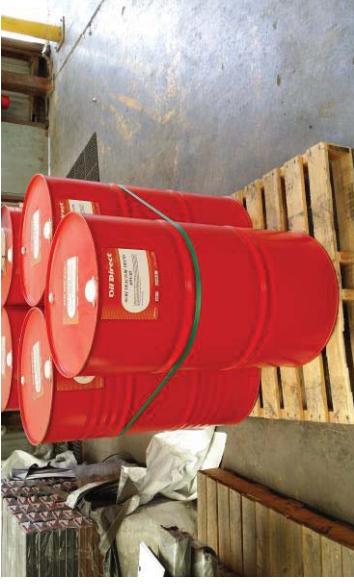
ITEM	REFERENCE	VERIFICATION / REQUIREMENT	EVIDENCE OF IMPLEMENTATION	COMPLIANCE STATUS
70.	Cont'd	Several oil drums (albeit in the field warehouse) were not be installed on pallets:

- OFI 4. There is room for improvement in management of chemicals and related fuel spills, this audit noting several minor tenant incidents to date, including 2 new minor leaks on the day. Additionally, it is suggested that 105L drums of oil (as with any other chemicals) should be stored on splash pallets or equivalent.
